# The Flood of August 2016- Weiner Creek Damage

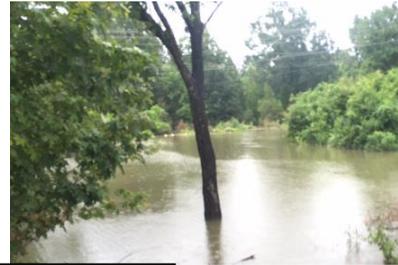
Weiner Creek Flooding

Weiner Creek is usually a slow meandering flow (sometimes a trickle) about 15-20 ft. below the bank. During the flood, the water overflowed the area on both sides of the creek.

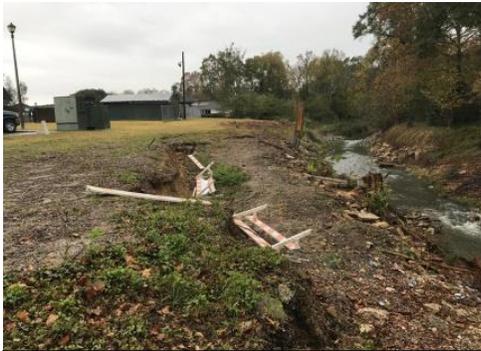
Looking toward the Pool Area

After the water subsided, the banks of the creek started to slough off and erode. The erosion came dangerously close to the pool area, the electrical boxes and the BR Sewage Disposal Plant

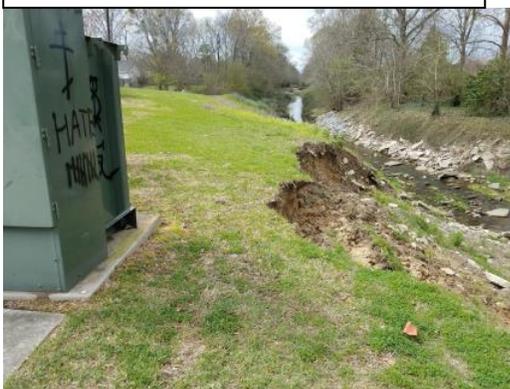
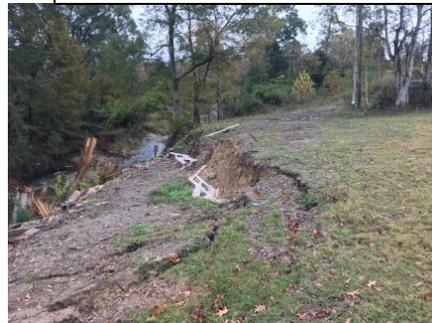
Looking away from the Pool Area

The SLA contacted Councilman Buddy Amoroso and he immediately came and reviewed the damage. He contacted city/parish officials and later informed the SLA that because the damage was due to flooding, that FEMA/Federal Government had to be involved with the city/parish. The area was then cordoned off for safety reasons by the city/parish

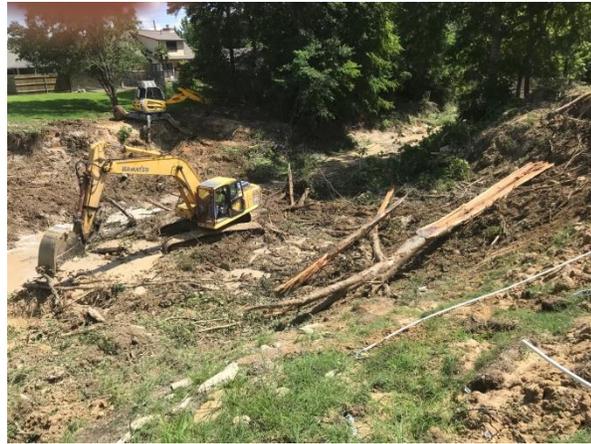
Trees had to be cut down and removed on both sides of the Creek.

It was a while before the Federal Government and the city/parish reached agreement and after a year or so, the repairs started. It was a long arduous process with the use of heavy equipment.

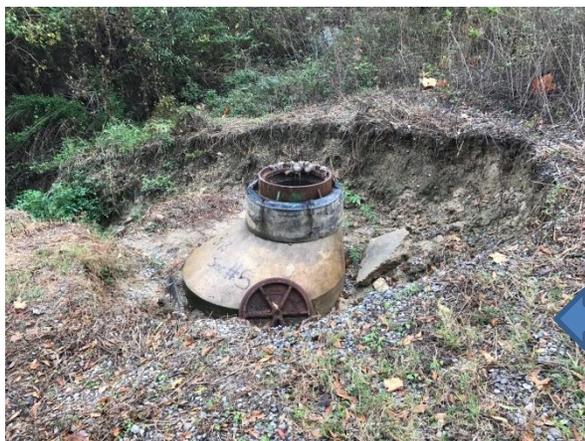
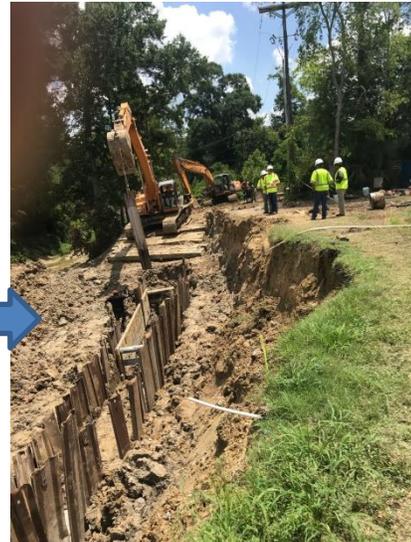
Sewer repair

Problems occurred as a broken sewer line was discovered and warranted repairs before any further remediation could be done.
